Flood Control Project Maintenance
Levee Inspections

Fall 2013 Levee Maintenance Deficiency Summary Report

Reclamation District No. 1001 Nicolaus

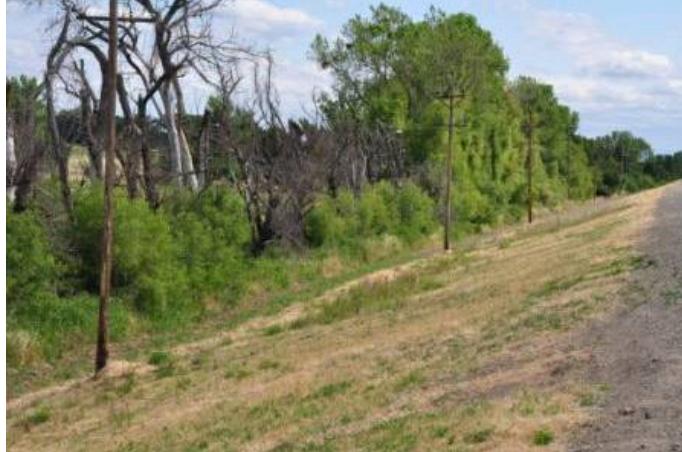
Levee Mile Report Line	2
Start Levee Mile	0.19
End Levee Mile	0.86
Location	Land Side
Category	Earthen Levee
Item	Encroachments
RD 1001 Unit 5 - L/S Levee Toe - Poles	
mhoffman_f_20130917_265.JPG

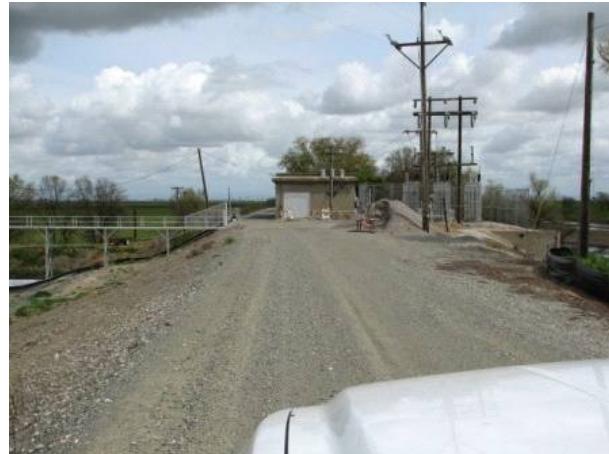
Levee Mile Report Line	9
Start Levee Mile	0.83
End Levee Mile	0.83
Location	Water Side
Category	Earthen Levee
Item	Encroachments
Pump house on the water side levee mile 0.83.	mhoffman_f_20130917_262.jpg

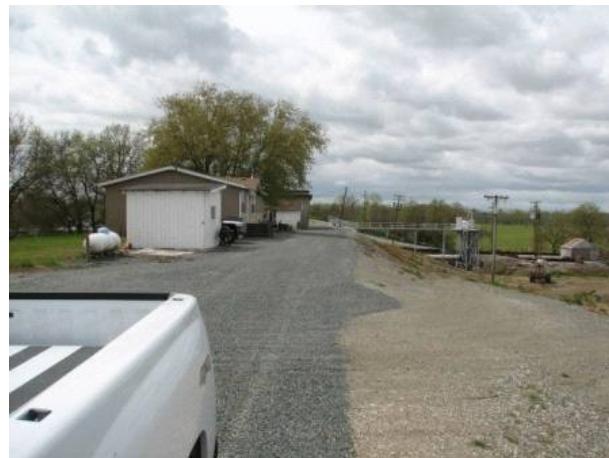
Levee Mile Report Line	9
Start Levee Mile	0.83
End Levee Mile	0.83
Location	Water Side
Category	Earthen Levee
Item	Encroachments
Pump house and Caretakers home levee mile 0.83	mhoffman_f_20130917_263.jpg

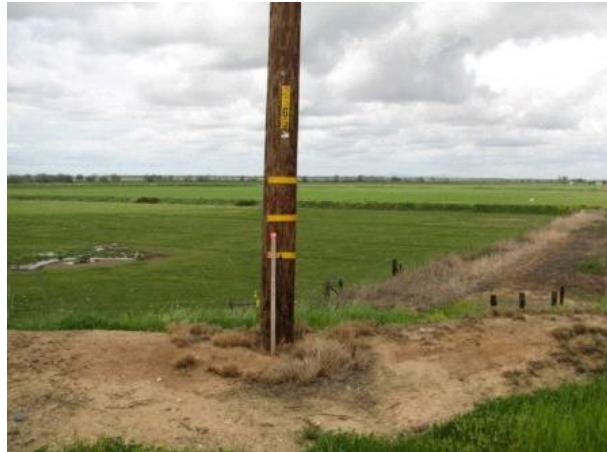
Levee Mile Report Line	10
Start Levee Mile	1.15
End Levee Mile	1.15
Location	Land Side
Category	Earthen Levee
Item	Encroachments
Pole on land side shoulder.	
mhoffman_f_20130917_267.jpg

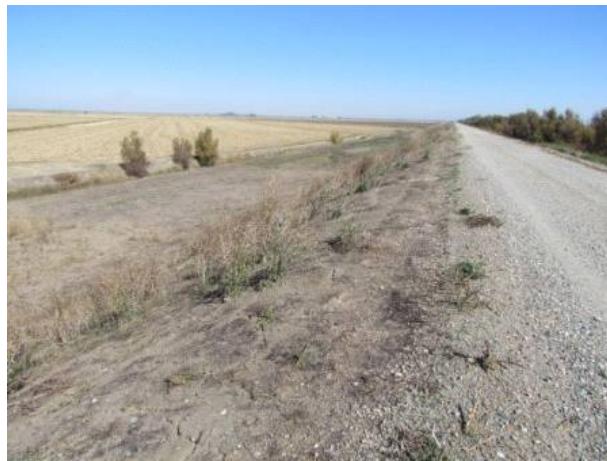
Levee Mile Report Line	11
Start Levee Mile	1.64
End Levee Mile	1.64
Location	Land Side
Category	Earthen Levee
Item	Vegetation
This photo was taken from the levee crown facing east looking at the vegetation on the landward slope.	
mhoffman_f_20131018_669.JPG

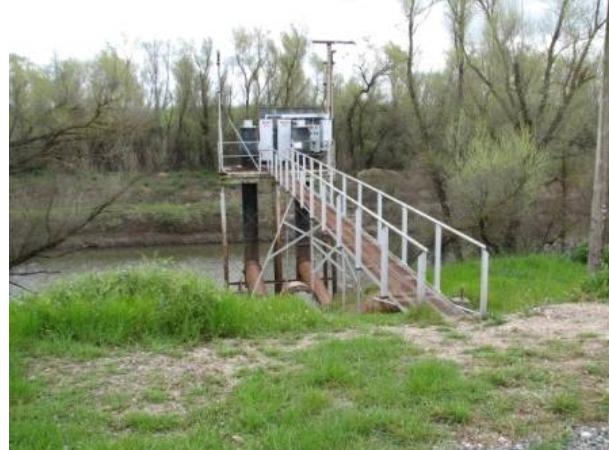
Levee Mile Report Line	14
Start Levee Mile	3.69
End Levee Mile	3.69
Location	Water Side
Category	Earthen Levee
Item	Encroachments
Pump water side levee mile 3.69.	
mhoffman_f_20130917_269.jpg

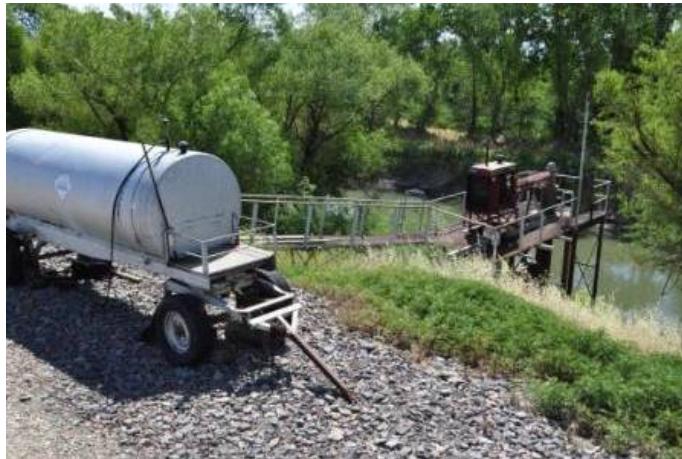
Levee Mile Report Line	15
Start Levee Mile	3.73
End Levee Mile	3.73
Location	Water Side
Category	Earthen Levee
Item	Encroachments
RD 1001 Unit 5 - W/S slope -Equipment & Portable Tank	
mhoffman_f_20130917_270.JPG

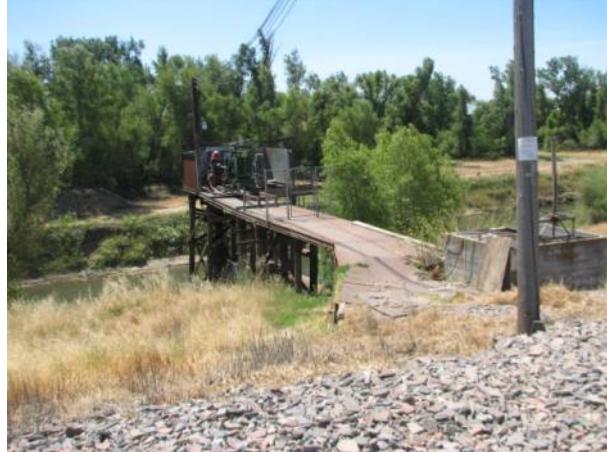
Levee Mile Report Line	16
Start Levee Mile	3.85
End Levee Mile	3.85
Location	Water Side
Category	Earthen Levee
Item	Encroachments
Pump and pipe through the levee with positive closure on the waterside. Spring 2013	mhoffman_f_20130917_273.JPG

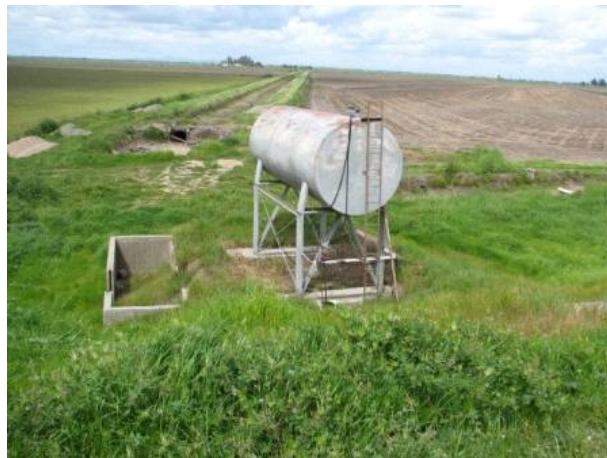
Levee Mile Report Line	17
Start Levee Mile	3.85
End Levee Mile	3.85
Location	Land Side
Category	Earthen Levee
Item	Encroachments
Storage tank on land side slope levee mile 3.85.	mhoffman_f_20130917_272.jpg

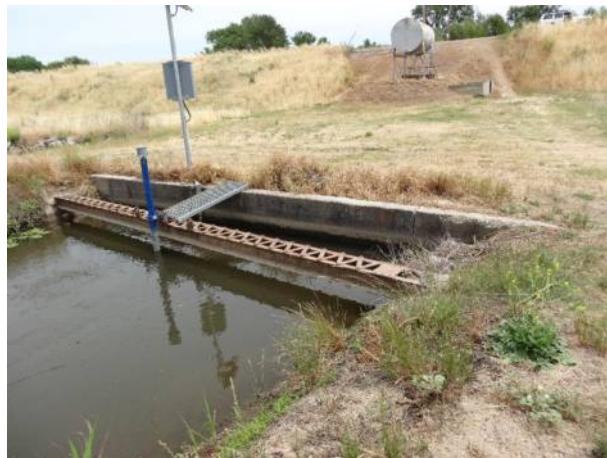
Levee Mile Report Line	19
Start Levee Mile	3.85
End Levee Mile	3.85
Location	Land Side
Category	Supplemental
Item	DWR UCIP Field Study
LS- headwall and irrigation ditch on levee toe (top)	UCIP_7680.jpg

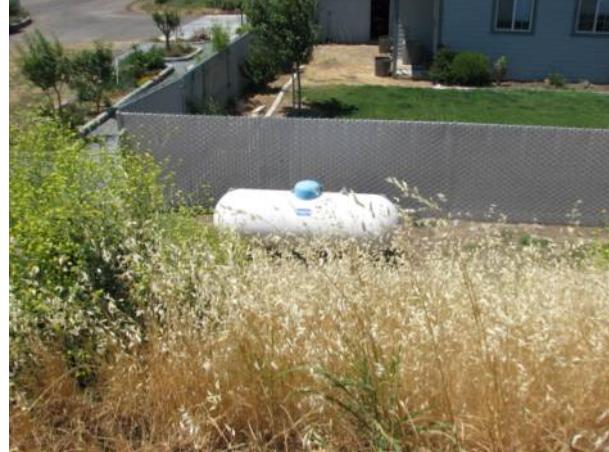
Levee Mile Report Line	1
Start Levee Mile	0.95
End Levee Mile	0.95
Location	Land Side
Category	Earthen Levee
Item	Encroachments
A propane tank is within the easement of the levee. Spring 2013	
mhoffman_f_20130917_281.JPG

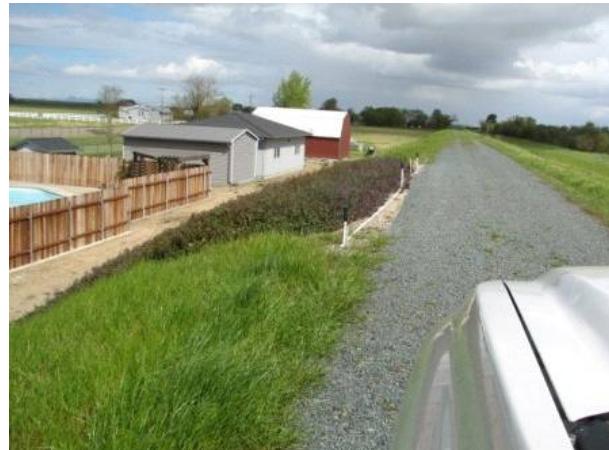
Levee Mile Report Line	2
Start Levee Mile	1.06
End Levee Mile	1.06
Location	Land Side
Category	Earthen Levee
Item	Vegetation
Landscaping on the landside slope LM 1.06.	
mhoffman_f_20130917_276.jpg

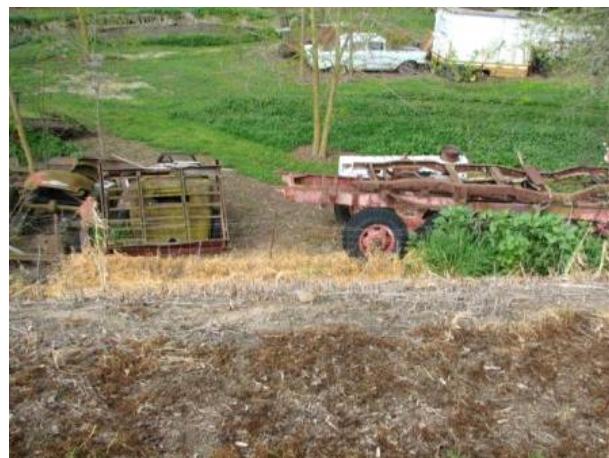
Levee Mile Report Line	3
Start Levee Mile	1.37
End Levee Mile	1.37
Location	Land Side
Category	Earthen Levee
Item	Encroachments
Equipment at the landside toe LM 1.37.	
mhoffman_f_20130917_277.jpg

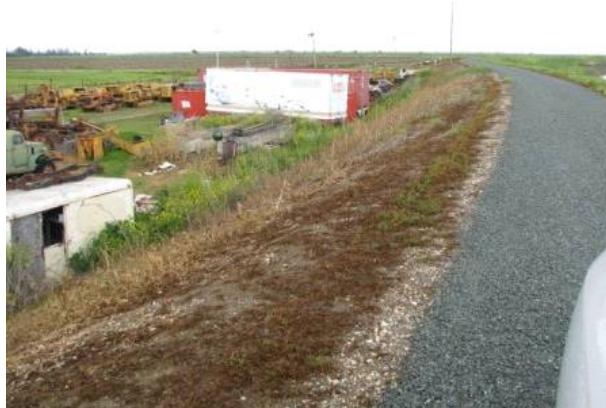
Levee Mile Report Line	5
Start Levee Mile	1.45
End Levee Mile	1.45
Location	Land Side
Category	Earthen Levee
Item	Encroachments
Equipment at the landside toe LM 1.45.	
mhoffman_f_20130917_275.jpg

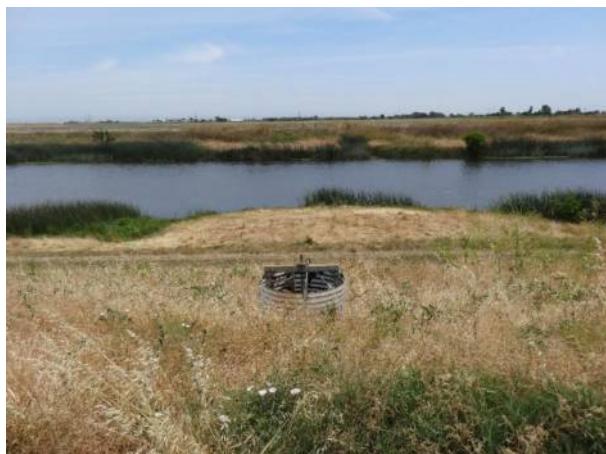
5	1.45	1.45	Earthen Levee	Encroachments	LS En	M	EQ : Equipment	38.851272 °	38.851272 °	3	
								-121.524357 °	-121.524357 °	Y	
								DWR ID: DWR_RD1001_06_s_2012_3			
6	1.73	1.73	Supplemental DWR UCIP Field Study	LS En	M	Inspector Comments: FS_ID:14244 EP_NO: N/A Repair Type: Non-Urgent Crossing Status: Found UCIP Comments: - visible damage to pipe on opening at inlet due to high corrosion.- video inspection recommended. FIELD_STRUCT_DESC: 36-inch corrugated-metal drainage pipe through the levee, 12.5 feet below the crown, slide gate in a 48-inch corrugated-metal pipe riser on the waterward slope, concrete headwall at the landward toe, the pipe crosses under the channel. FS Date: 5/15/2013			38.855186 °	-121.524895 °	2

Levee Mile Report Line	6
Start Levee Mile	1.73
End Levee Mile	1.73
Location	Land Side
Category	Supplemental
Item	DWR UCIP Field Study
WS- slide gate in CMP riser on levee slope.	
UCIP_7591.jpg

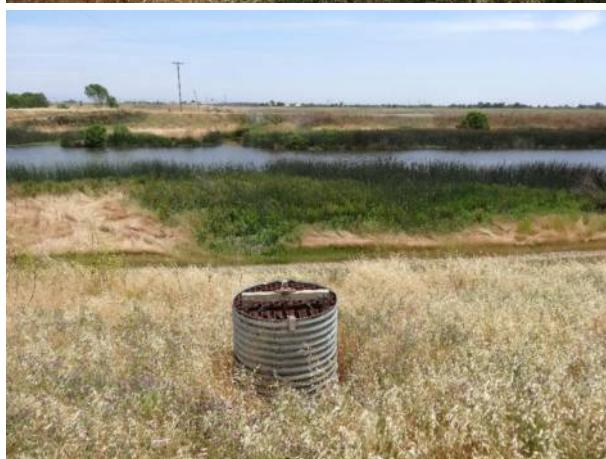
Waterway							Bank	Unit Miles	Inspection Start/End	Inspector
LMR No.	Levee Mile		Category	Item	* Location Start	* Rating +	Action/Comment	GPS Latitude/Longitude		Issue No. Photo
	Start	End						Start	End	
8	2.03	2.03	Supplemental DWR UCIP Field Study		CR M En		Inspector Comments: FS_ID:14223 EP_NO: N/A Repair Type: Non-Urgent Crossing Status: Found UCIP Comments: - pipe burried/submerged on LS- needs cleaning of LS pipe end opening. FIELD_STRUCT_DESC: 24-inch corrugated-metal drainage pipe through the levee, 15.5 feet below the crown, slide gate in a 36-inch corrugated-metal pipe riser on the waterward slope, concrete headwall at the landward toe, the pipe crosses under the channel FS Date: 5/15/2013	38.859601 °	-121.524885 °	10

Levee Mile Report Line	8
Start Levee Mile	2.03
End Levee Mile	2.03
Location	Land Side
Category	Supplemental
Item	DWR UCIP Field Study
WS- slide gate in CMP riser on levee slope.	
UCIP_7583.jpg

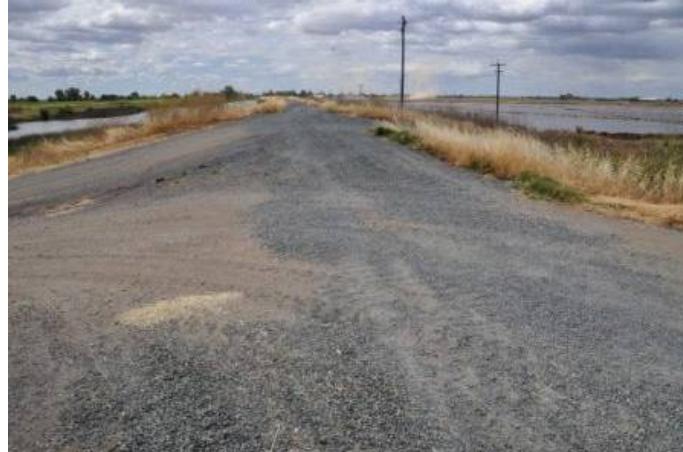
38.859601 °	-121.524885 °	Y
9	2.06	2.06	Earthen Levee	Slope Stability	CR M Ma		S3 : Repair the levee slope damaged by vehicle traffic and prevent access where possible. Inspector Comments: Subsidence due to traffic across levee crown.	38.860002 °	38.860002 °	8
								-121.524873 °	-121.524873 °	Y
										DWR ID: DWR_RD1001_06_s_2012_8
10	2.29	2.29	Supplemental DWR UCIP Field Study		CR U En		Inspector Comments: FS_ID:14204 EP_NO: 12208 Repair Type: Urgent Crossing Status: Found UCIP Comments: - large pit at pipe daylight on WS berm, may be due to pipe leakage.- siphon breaker on LS shoulder not found. FIELD_STRUCT_DESC: 16-inch irrigation pipe through the levee, 3.0 feet below the crown, 16-inch low-lift pump in the channel, 36-inch corrugated-metal pipe riser on the bank, siphon breaker on the landward shoulder (Permit No. 12208, 1977) FS Date: 5/15/2013	38.863385 °	-121.524866 °	11

Levee Mile Report Line	9
Start Levee Mile	2.06
End Levee Mile	2.06
Location	Crown
Category	Earthen Levee
Item	Slope Stability
RD 1001 Unit 6 - Levee Crown - Subsidence due to vehicle traffic.	
mhoffman_f_20130917_279.JPG

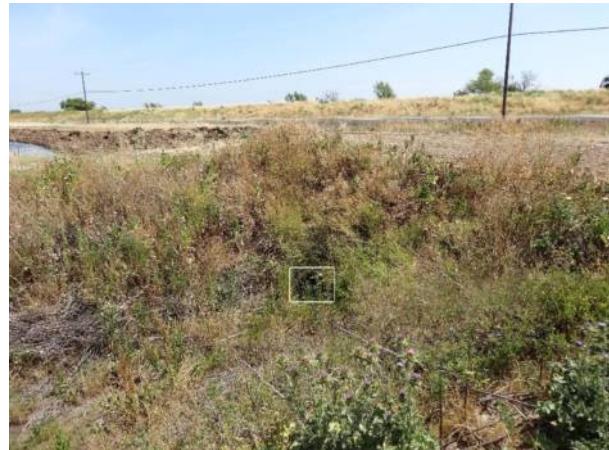
Waterway							Bank	Unit Miles	Inspection Start/End	Inspector			
L/MR No	Levee Mile		Category	Item	* Location	** Rating	Action/Comment			GPS Latitude/Longitude	Issue No.		
	Start	End					Start	End	Photo				
12	3.28	3.28	Supplemental	DWR UCIP Field Study	CR	M En	Inspector Comments: FS_ID:14146 EP_NO: N/A Repair Type: Non-Urgent Crossing Status: Found UCIP Comments: - pipe opens in irrigation ditch on landside.- vegetation cleaning on LS pipe opening. FIELD_STRUCT_DESC: 24-inch corrugated-metal drainage pipe through the levee, 12.0 feet below the crown, slide gate in a 36-inch corrugated-metal pipe riser on the waterward slope, concrete headwall at the landward toe, the pipe crosses under the channel FS Date: 5/15/2013	38.877691 °	-121.524766 °	13	38.877691 °	-121.524766 °	Y
13	3.29	3.29	Supplemental	DWR UCIP Field Study	CR	M En	Inspector Comments: FS_ID:14165 EP_NO: N/A Repair Type: Non-Urgent Crossing Status: Found UCIP Comments: - pipe opens in irrigation ditch on landside.- vegetation cleaning on LS pipe opening. FIELD_STRUCT_DESC: 24-inch corrugated-metal drainage pipe through the levee, 12.0 feet below the crown, slide gate in a 36-inch corrugated-metal pipe riser on the waterward slope, concrete headwall at the landward toe, the pipe crosses under the channel FS Date: 5/15/2013	38.877691 °	-121.524766 °	14	38.877691 °	-121.524766 °

Levee Mile Report Line	12
Start Levee Mile	3.28
End Levee Mile	3.28
Location	Crown
Category	Supplemental
Item	DWR UCIP Field Study
LS- CMP opens in irrigation ditch.	
UCIP_7562.jpg

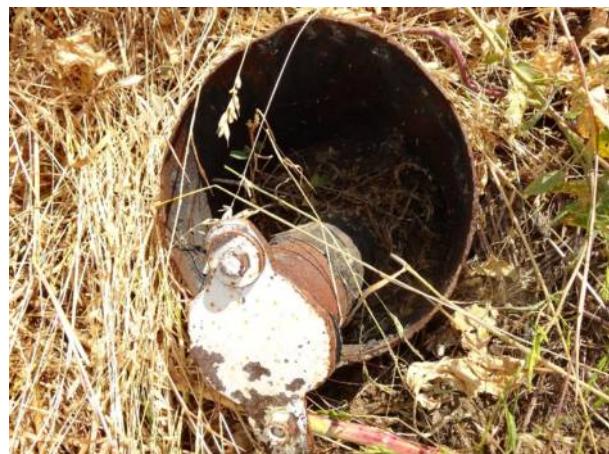
Levee Mile Report Line	15
Start Levee Mile	3.44
End Levee Mile	3.44
Location	Crown
Category	Supplemental
Item	DWR UCIP Field Study
WS- gap between two pipes needs to be filled.	
UCIP_7324.jpg

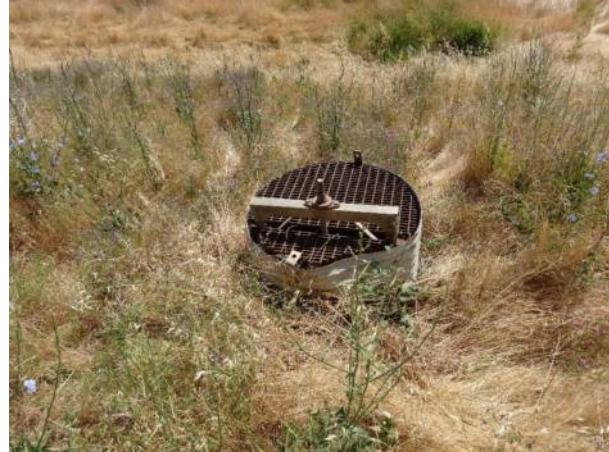
Waterway								Bank	Unit Miles	Inspection Start/End	Inspector
LMR No.	Levee Mile		Category	Item	* Location	** Rating	Action/Comment	GPS Latitude/Longitude		Issue No.	
	Start	End						Start	End		
16	3.60	3.60	Supplemental DWR UCIP Field Study	CR M En	Inspector Comments: FS_ID:13509 EP_NO: N/A Repair Type: Non-Urgent Crossing Status: Found UCIP Comments: Only a small section of head wall visible, almost buried. FIELD_STRUCT_DESC: 24-inch corrugated-metal drainage pipe through the levee, 12.0 feet below the crown, slide gate in a 36-inch corrugated-metal pipe riser on the waterward slope, concrete headwall at the landward toe, the pipe crosses under the channel FS Date: 5/15/2013			38.882247 °	-121.524762 °	17

Levee Mile Report Line	16
Start Levee Mile	3.60
End Levee Mile	3.60
Location	Crown
Category	Supplemental
Item	DWR UCIP Field Study
WS- fixed slide gate in CMP riser on levee slope.	UCIP_7323.jpg

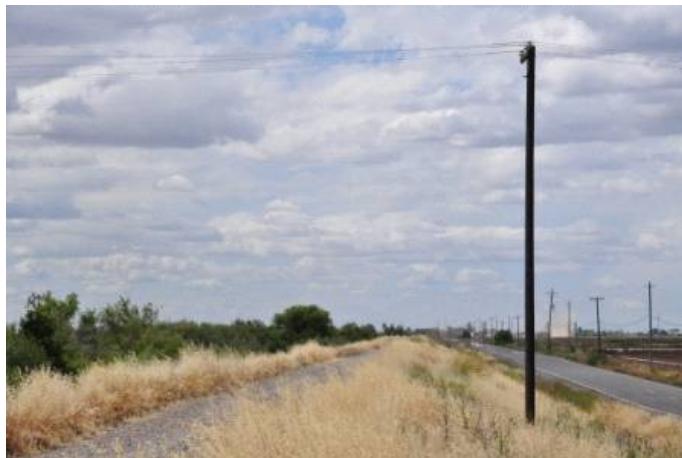
38.882247 °	-121.524762 °	Y	
17	3.70	3.70	Earthen Levee	Encroachments LS En	WL : Wall			38.883804 °	38.883804 °	48	
								-121.524766 °	-121.524766 °	Y	
								DWR ID: DWR_RD1001_06_s_2012_48			
18	3.93	3.93	Supplemental DWR UCIP Field Study	LS En	Inspector Comments: FS_ID:13485 EP_NO: N/A Repair Type: Urgent Crossing Status: Found UCIP Comments: - mud/soil debris on LS pipe end.- highly corroded pipe in outlet.- may require video inspection or pressure test. FIELD_STRUCT_DESC: 24-inch corrugated-metal drainage pipe through the levee, 12.2 feet below the crown, slide gate in a 36-inch corrugated-metal pipe riser on the waterward slope, concrete headwall at the landward toe, the pipe crosses under the channel FS Date: 5/15/2013				38.887003 °	-121.524746 °	18

Levee Mile Report Line	17
Start Levee Mile	3.70
End Levee Mile	3.70
Location	Land Side
Category	Earthen Levee
Item	Encroachments
RD 1001 Unit 6 - L/S Slope - Pole	mhoffman_f_20130917_282.JPG

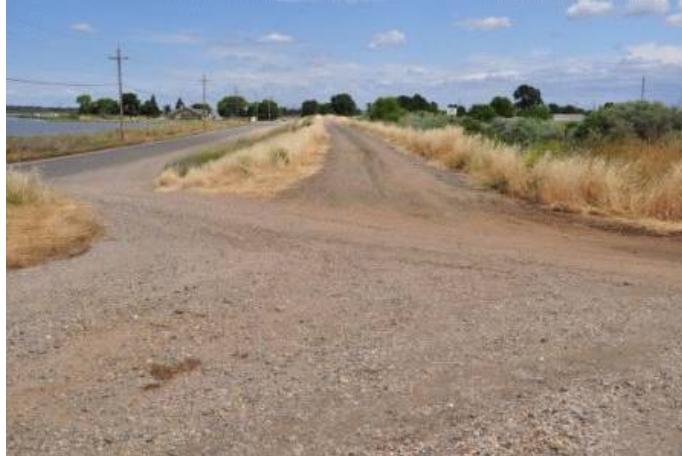
38.887003 °	-121.524746 °	Y	
								DWR ID: DWR_RD1001_06_f_2013_18			
19	4.05	4.05	Earthen Levee	Slope Stability CR Ma	S3 : Repair the levee slope damaged by vehicle traffic and prevent access where possible. Inspector Comments: Levee crown subsided due to vehicle traffic across crown.			38.888821 °	38.888821 °	7	
								-121.524733 °	-121.524733 °	Y	
								DWR ID: DWR_RD1001_06_s_2012_7			
20	4.35	4.35	Earthen Levee	Slope Stability CR Ma	S3 : Repair the levee slope damaged by vehicle traffic and prevent access where possible. Inspector Comments: Levee crown subsided due to vehicle traffic across crown.			38.893114 °	38.893114 °	19	
								-121.524715 °	-121.524715 °	Y	
								DWR ID: DWR_RD1001_06_f_2013_19

Levee Mile Report Line	19
Start Levee Mile	4.05
End Levee Mile	4.05
Location	Crown
Category	Earthen Levee
Item	Slope Stability
RD 1001 Unit 6 - Levee Crown - Subsidence due to vehicle traffic.	
mhoffman_f_20130917_278.JPG
